COSTA DE COCOS WIND-DIESEL HYBRID SYSTEM

RESULTS OF THREE YEARS OF MONITORING

Abraham Ellis, Luis Estrada

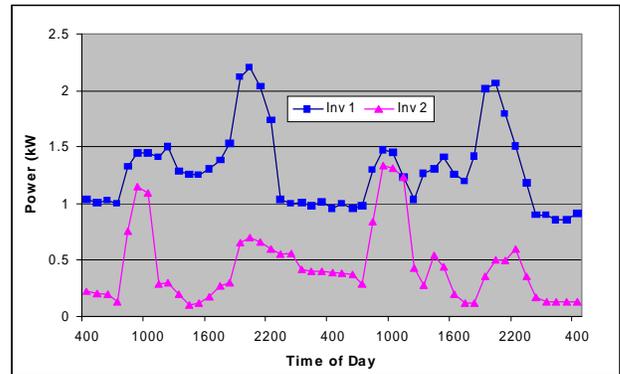
sensors (Fig 3). The peak load for circuit 1 and 2 was about 1.6 kW and 1.0 kW, respectively, and the average load was 0.86 and 0.29 kW, respectively. A load profile for April 1-2, 1999 is shown in Fig. 5. Note that both inverters run continuously and therefore operate at a low efficiency range most of the time, even if a conservative power factor is assumed. The average capacity factors are only 16% and 5%, respectively. Assuming a conservative power factor (70% or higher), it appears that this load could be served by a single inverter and the overall losses could be lowered. The system was designed with two 5.5 kW stacked inverters to supply the 240-volt RO pump motor.

Fig. 6: Typical daily load profile (April 1-2, 1999)

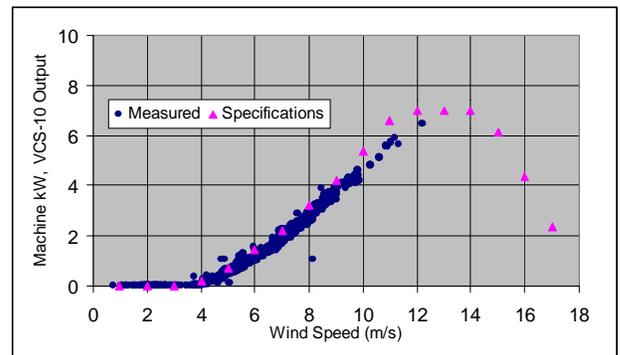
Fig. 7 shows a power curve taken in February 1997 using 1-minute samples. VCS-10 regulation was not a factor because the battery voltage remained below regulation during the test. The peak power is about 7 kW at 14 m/s and the cut-in speed is about 4.2 m/s. The experimental curve is consistent with the manufacturer performance estimates for this machine at sea level in a battery-charging application¹, as shown in Fig 6.

Fig. 7 Bergey Excel measured and expected performance at sea level. 12% turbulence factor

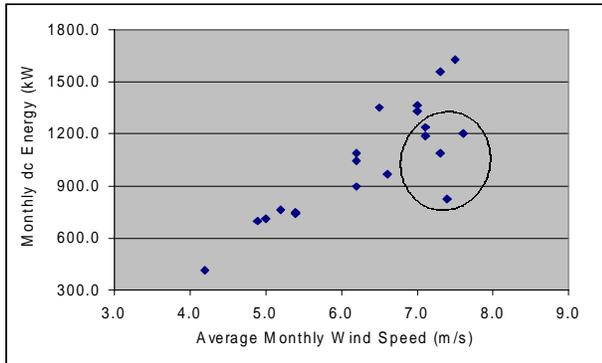
The wind machine has been delivering an average of 1043 kWh/month (43.5 kWh/day) measured at the output of the VCS-10. This corresponds to a capacity factor of about 21% using a 7-kW machine rating. The total monthly energy delivered by the wind machine is plotted against the average wind speed in Fig. 8. An interesting observation is that the data points circled correspond to the earlier months of operation of the system, where the batteries were new.

Fig. 8: Monthly dc energy delivered by the wind machine (circled points correspond to first months of system operation)
